INVESTIGATION OF GREASE-LUBRICATED EXPENDABLE SPLINE CONNECTIONS

FINAL TECHNICAL REPORT
Contract N68335-75-C-1117

Naval Weapons Engineering Support Activity
Systems Engineering Department
Washington Navy Yard
Washington, D.C. 20374

October 20, 1976

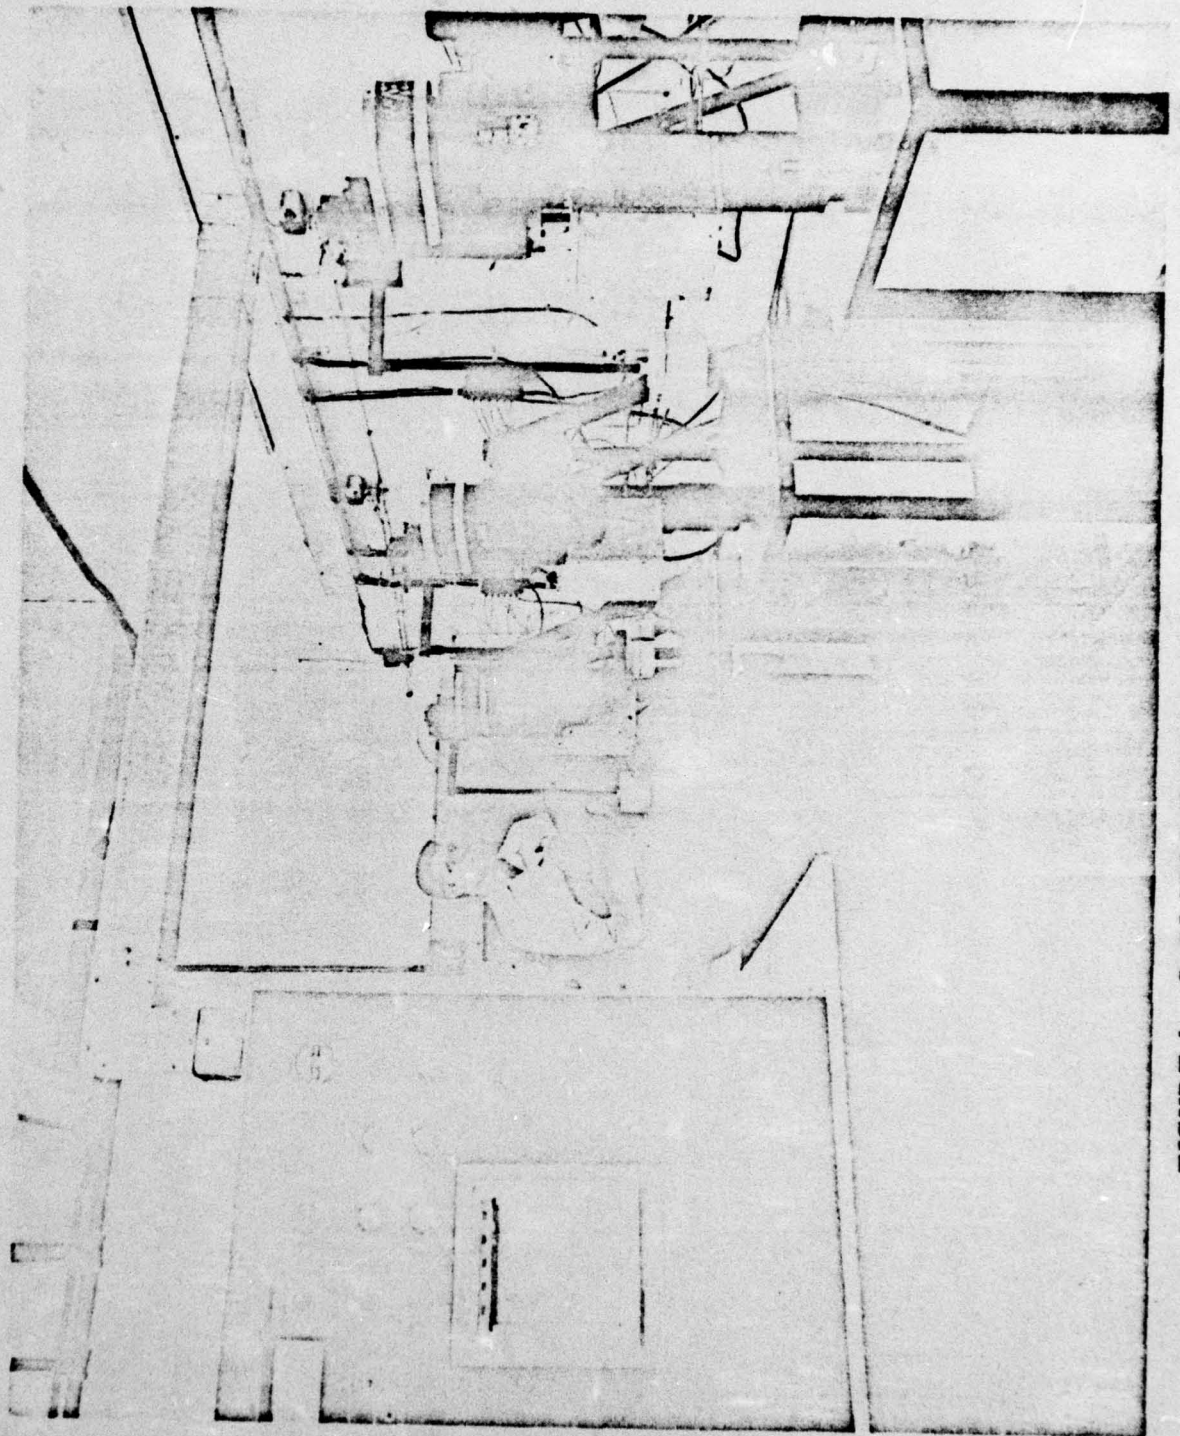
FIGURE 1. SwRI SPLINE WEAR TEST FACILITY

A photograph of the SwRI spline wear test facility is presented in Figure 1. The facility has three independent testers of identical design. Testers S-1 and S-2 are shown in the foreground, while tester N-1 is shown adjacent to the operator.

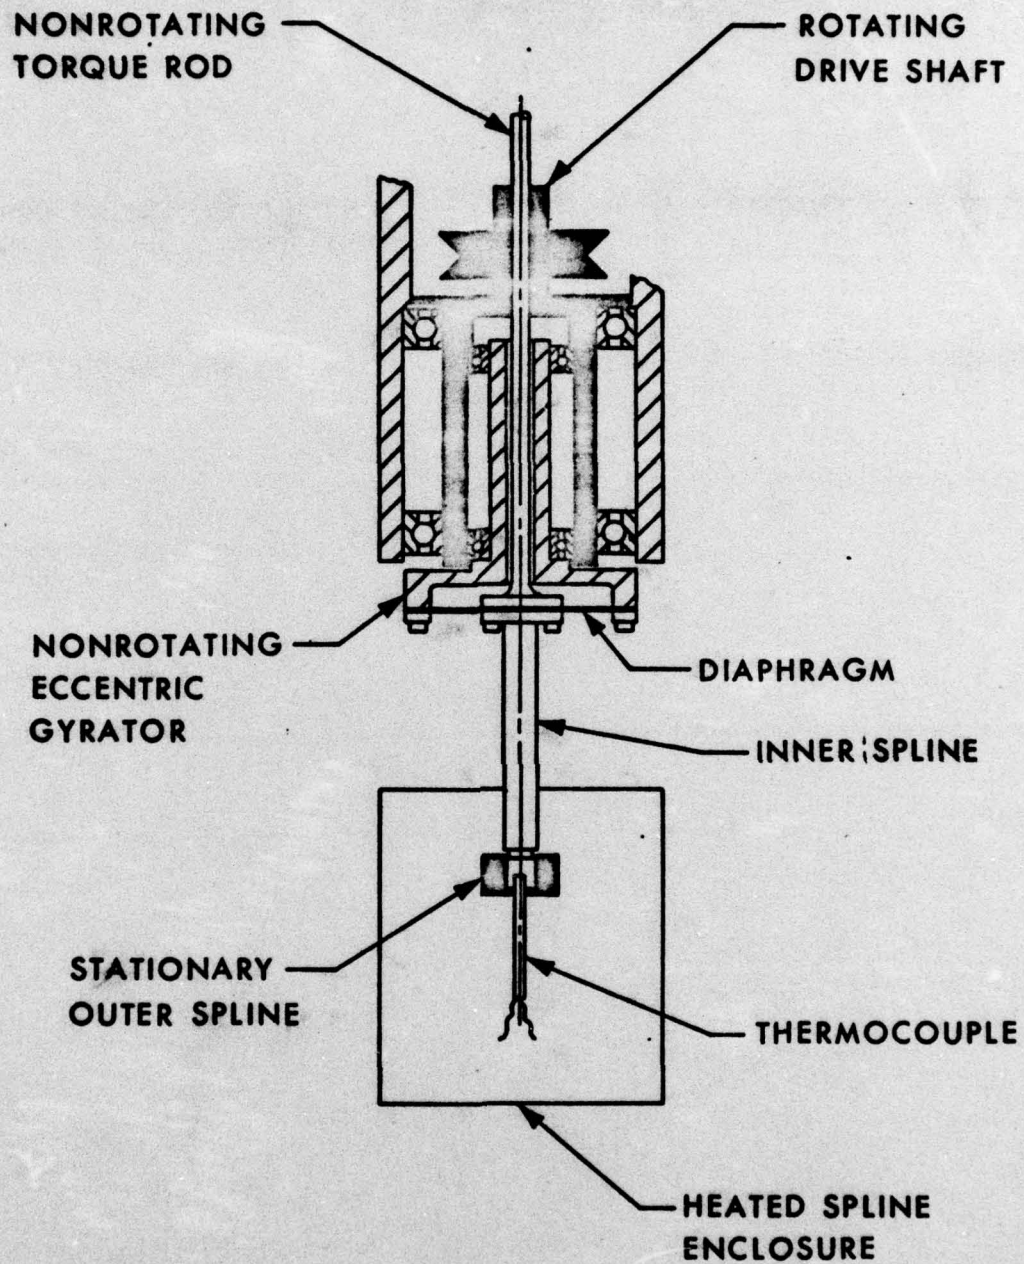
**FIGURE 2. SCHEMATIC REPRESENTATION OF THE
SPLINE WEAR TESTER**

A schematic representation of the tester is given in Figure 2. As noted in this figure, the outer spline is clamped in a fixed position. The flanged end of the inner spline is attached to a diaphragm, gyrator, and a torque rod. During a typical test, the flanged end of the inner spline is caused to gyrate without rotating, thereby simulating the relative oscillatory motion of a pair of angularly misaligned splines. This oscillatory motion is produced by placing the nonrotating gyrator shaft eccentrically within the hollow rotating drive shaft. A timing belt drive is used between the drive shaft and the drive motor to eliminate the possibility of belt slippage.

In order to accommodate the built-in eccentricity at the upper end of the inner spline, a diaphragm is employed to provide the necessary flexibility between the gyrator shaft and the drive shaft. A flexible torque-transmitting rod is extended upward through the hollow gyrator shaft to a convenient location where the torque is applied. Since the torque rod is mounted vertically, a lever system is provided to allow the application of torsional load with deadweight in either a forward or reverse loading direction. As the spline teeth wear during a test, the deadweight gradually moves downward, and the changing position of the load arm is continuously monitored and recorded.

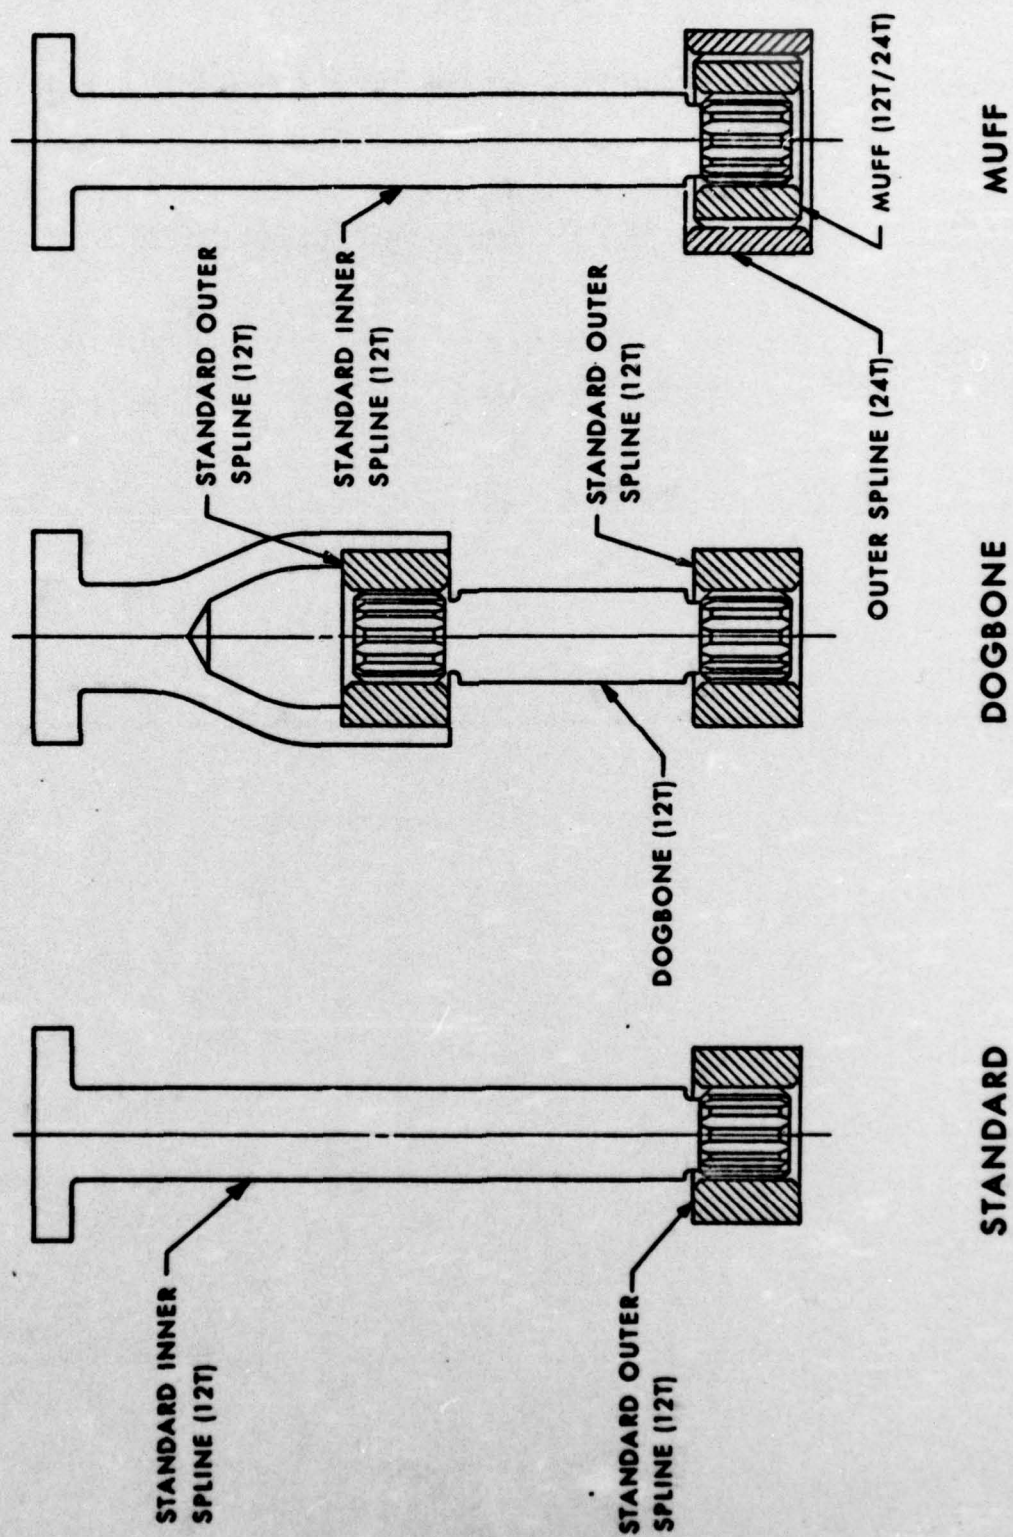
FIGURE 3. SPLINE TEST SPECIMEN CONFIGURATION

<u>Standard</u>	<u>Dogbone</u>	<u>Muff</u>
Flange to spline pivot length	5 in.	2.5 in. to upper outer spline and 5.0 in. to lower outer spline (for 2.5 in. dogbone) 2.5 in. to upper outer spline and 7.5 in. to lower outer spline (for 5.0 in. dogbone)	5 in.
Length of engagement	1/2 in.	1/2 in.	1/2 in.
Surface finish	32 rms	32 rms	32 rms

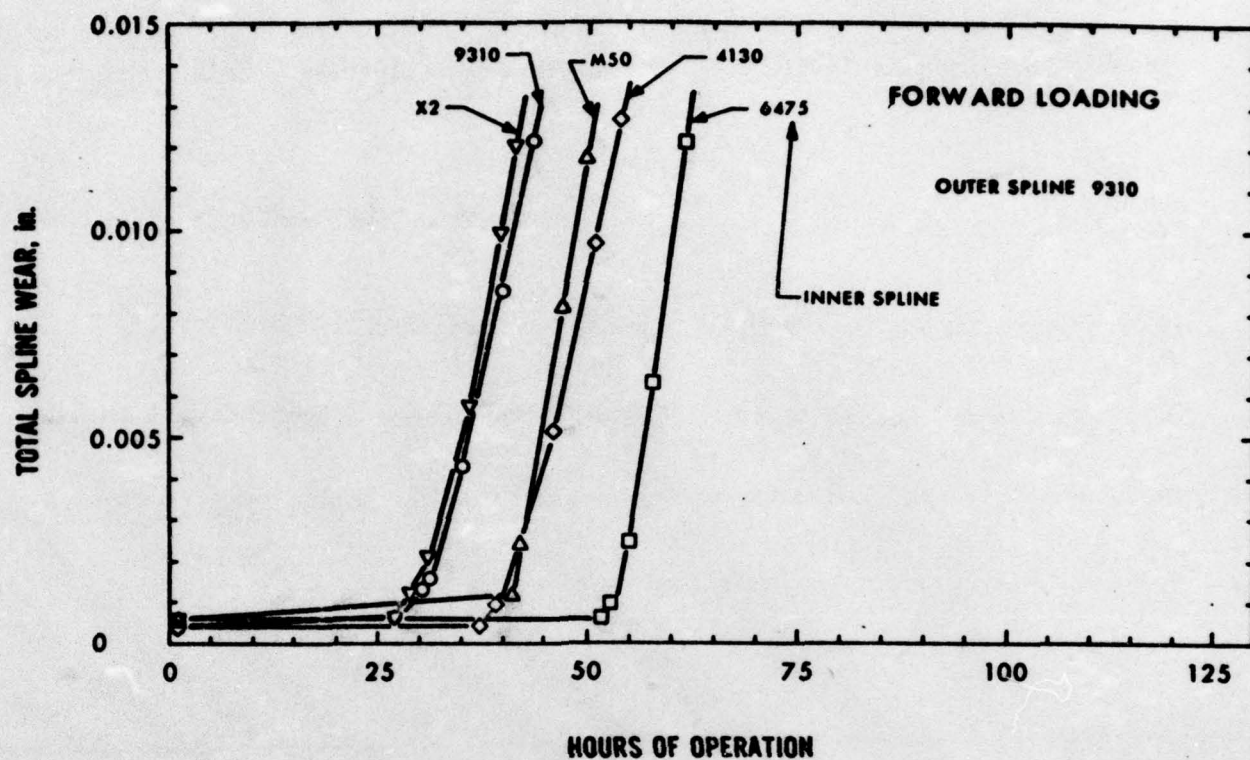
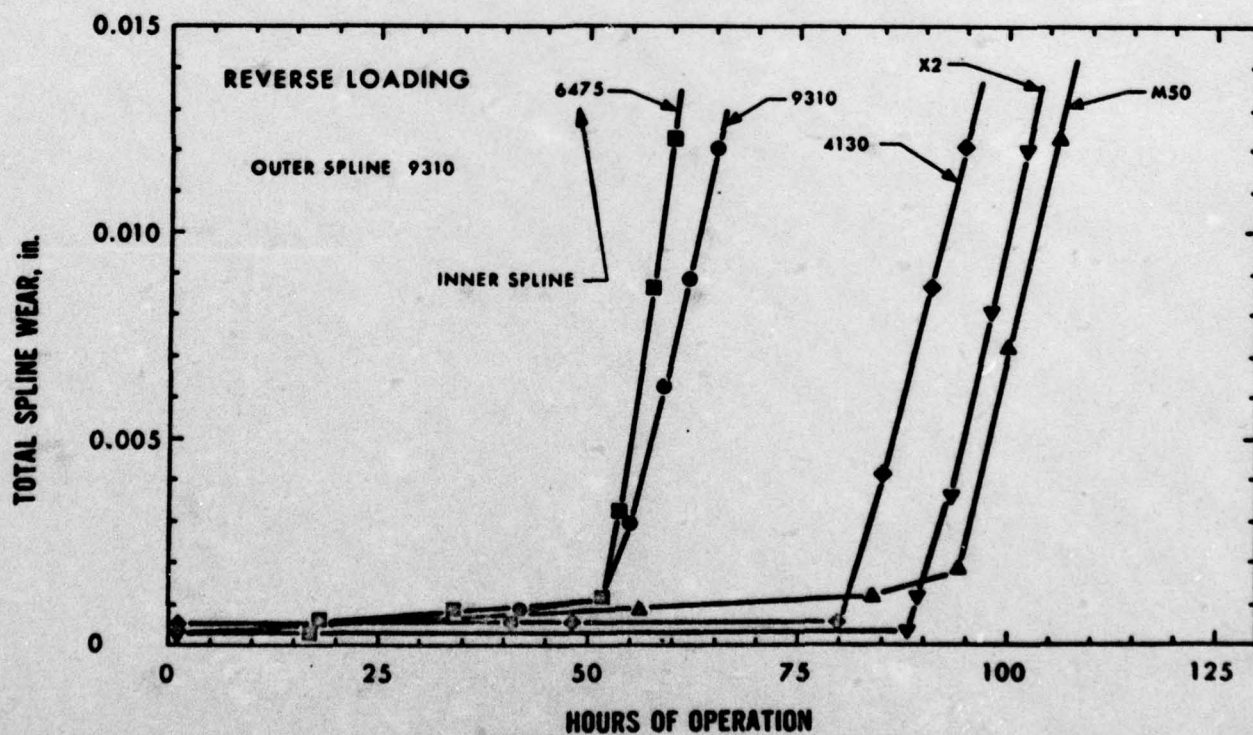
FIGURE 5. TYPICAL WEAR BEHAVIOR OF STANDARD SPLINES FOR DIFFERENT MATERIAL COMBINATIONS

The typical wear behavior of standard splines operating with the MIL-G-81322B grease in dry air in the forward and reverse loading directions is shown in Figure 5. The wear curves are presented with the abscissa denoting the hours of operation and the ordinate denoting the total spline wear of the inner and outer splines. Hollow symbols are used to indicate the first (forward loading) test with the repeat (reverse loading) test indicated by a solid symbol. In these tests, the outer splines were made of AISI 9310 steel, each operated against various inner spline materials.

In all of the tests, the test splines exhibited an initial minimal amount of wear of less than 0.001 in. for virtually all material combinations. After this initial period of negligible wear (referred to in earlier work as the "induction period"), (4,5) the spline connections began to wear at a very high rate.

An important factor to recognize is that, in most cases, the forward loading tests (which were performed first) operated for a shorter period of time than the reverse loading tests. The longer life of the reverse loading tests is attributed to the fact that more grease is available within the spline connection due to the worn spline teeth from the preceding forward loading test.

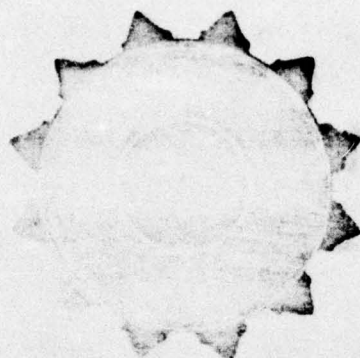
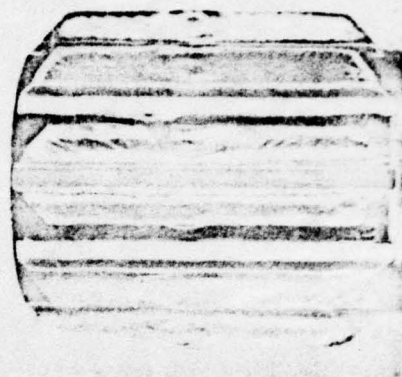
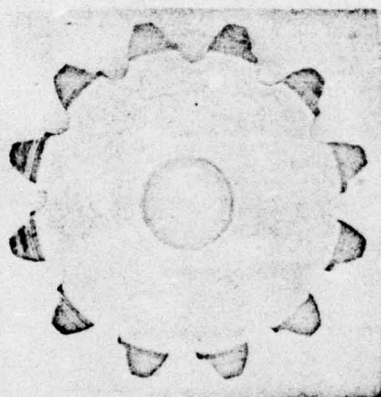
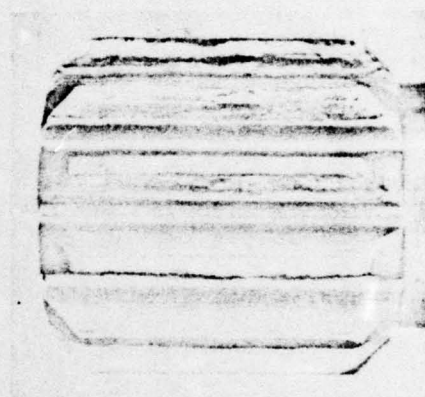
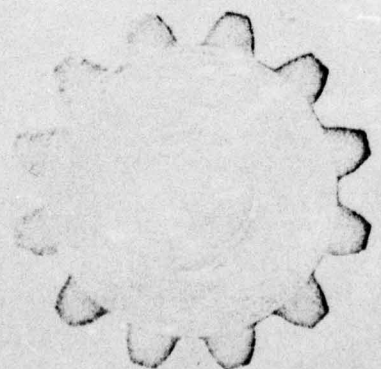
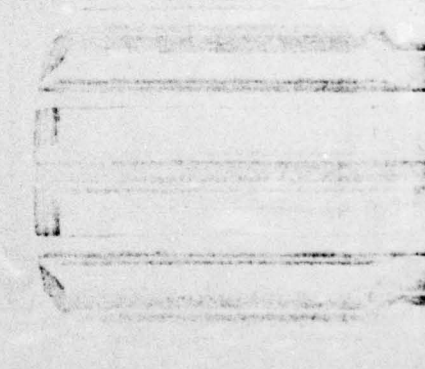
FIGURE 6. APPEARANCE OF STANDARD INNER SPLINES BEFORE AND AFTER FORWARD AND REVERSE LOADING TESTS

The appearance of the inner spline teeth before and after forward and reverse loading tests is presented in Figure 6. The lower left photograph shows the end of the "new" inner spline with the accompanying side view of the same spline on the adjacent photograph. The end view of the new spline shows the 12 spline teeth having the typical involute form. The adjacent photograph shows the length of the spline and the full width of the spline teeth. Note the smooth unworn surfaces on the spline teeth.

The photographs above the "new" splines show the wear step which is generated during the forward loading test. In most cases, the spline connections are allowed to operate for about 0.012 in. of total spline wear for the inner and outer splines. Therefore, after a typical forward loading test, the inner spline wears about 0.006 in. The photograph on the right shows the wear on one side of the spline teeth.

The top photographs show the appearance of the splines after operation in the forward and reverse loading directions. The end view of the teeth show the wear steps on both sides of the teeth. In actual practice, only one side of the teeth are worn similar to the "after forward loading test" condition. In rare instances, as in the case of an aircraft engine starter, both sides of the spline teeth receive some wear. In this program, tests were performed in the forward and reverse loading directions to alleviate the cost of the test specimens.

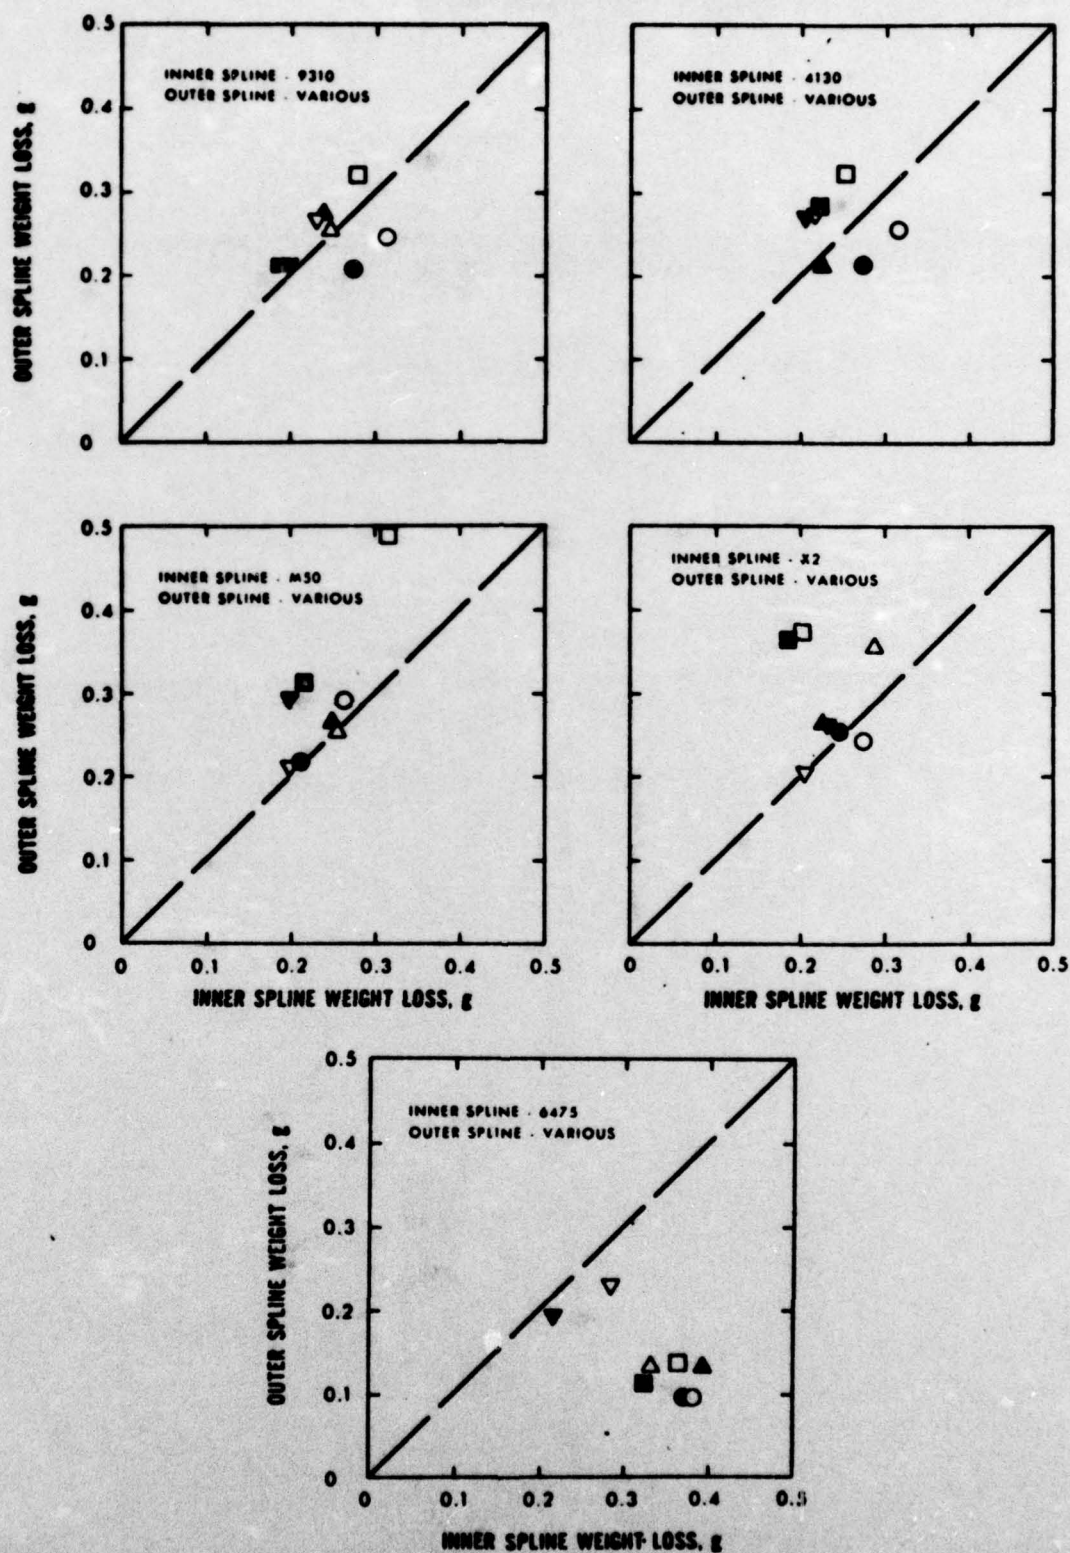
FIGURE 7. EFFECT OF WEIGHT LOSS ON STANDARD SPLINES FOR DIFFERENT MATERIAL COMBINATIONS

Each spline test specimen is weighed before and after each test to study the effect of spline weight loss. Figure 7 illustrates the effect of weight loss on standard splines for the different material combinations evaluated. As noted in the legend, the outer spline materials were made of AISI 9310, AMS 6475, AISI M50, and Vasco X2 steels, with the appropriate symbols listed. Each of the five plots are presented with the abscissa denoting the inner spline weight loss in grams and the ordinate denoting the outer spline weight loss in grams. The abscissa and ordinant are plotted on the same scale. A 45° dash line has been provided to assist in analyzing the data.

The bottom plot in Figure 7 shows the weight loss data for the inner splines made of AMS 6475 steel operating against other spline materials. The results clearly show the protection to the outer splines by using AMS 6475 steel as the inner spline material. In all cases the inner splines exhibited more weight loss than the outer splines. When compared to the most commonly used outer spline material AISI 9310 steel (see the clear and solid circle symbols), the inner splines exhibited about four times the wear of the outer AISI 9310 splines.

It is also interesting to note that virtually no differences in weight loss were noted between the forward and reverse loading tests for all of the material combinations investigated.

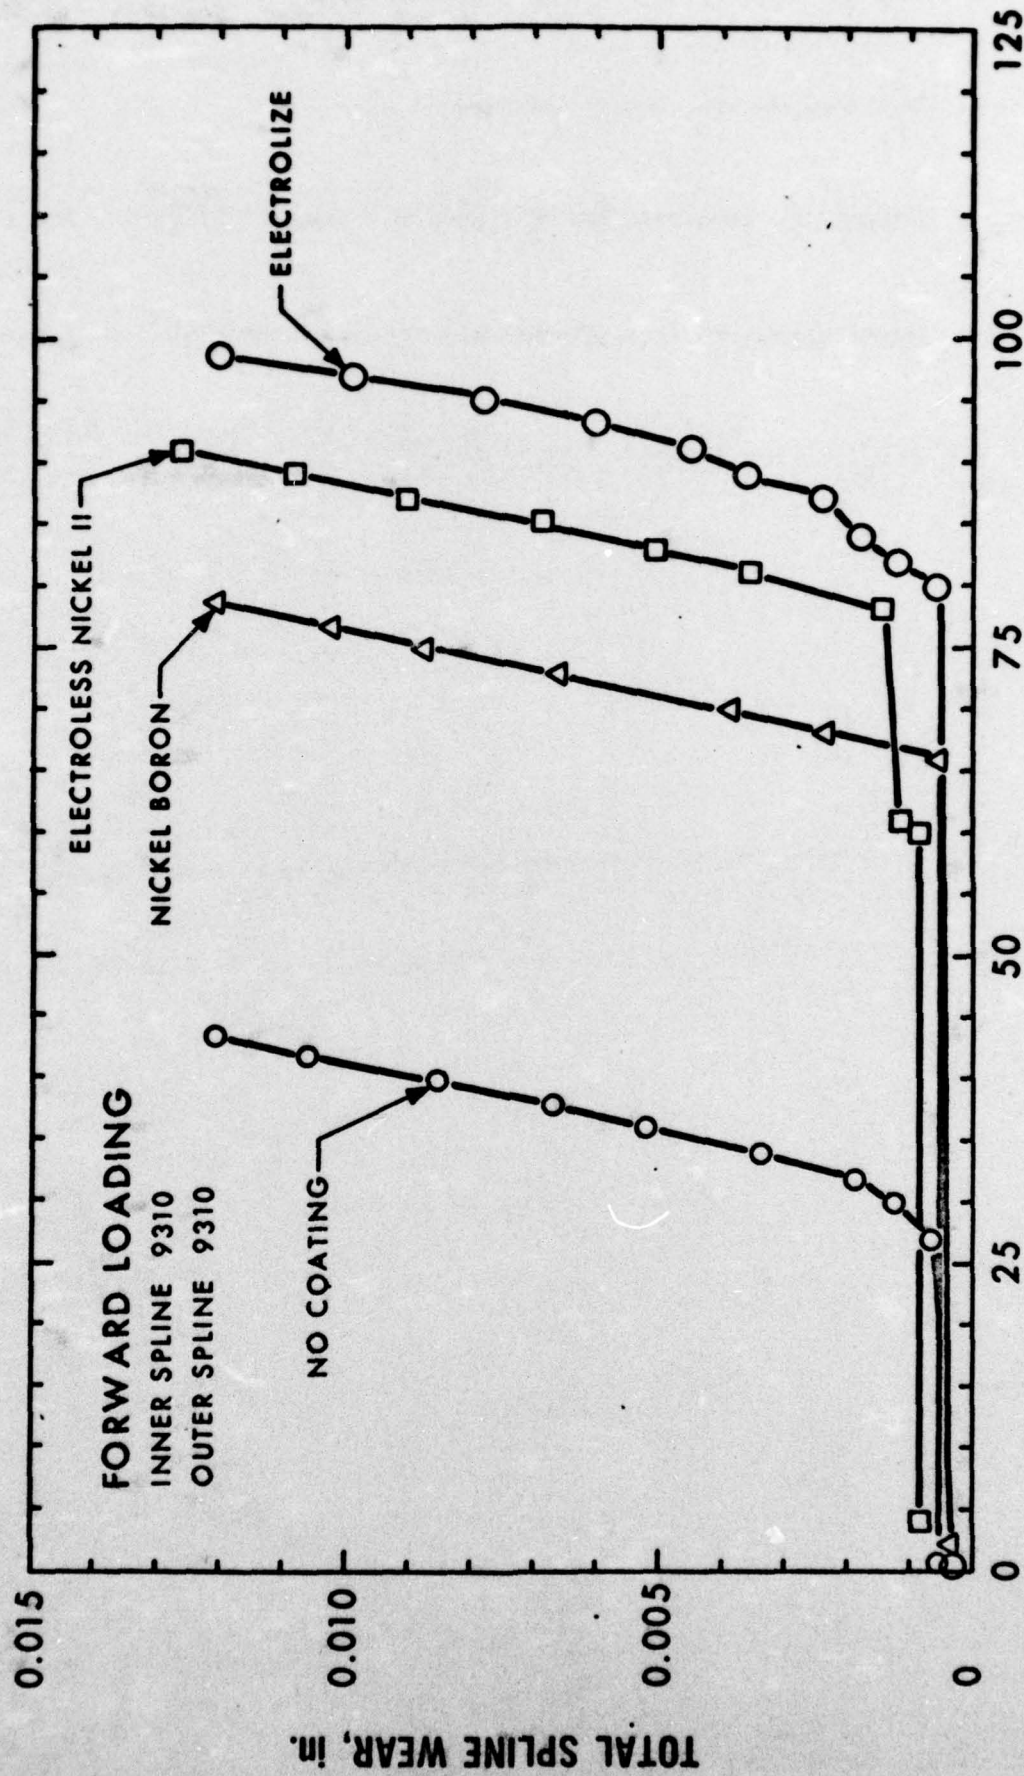
FIGURE 8. TYPICAL WEAR BEHAVIOR OF STANDARD SPLINES FOR DIFFERENT MATERIAL COMBINATIONS WITH METALLIC COATINGS

The wear behavior of three spline tests performed with standard splines with various metallic coatings is portrayed in Figure 8. The curves represent tests performed with AISI 9310 inner and outer splines operated in the forward loading direction. Metallic coatings were applied to the outer splines only.

In all cases the use of nickel boron, electroless nickel II, or Electrolize improved the spline life by at least two- to three-fold for the AISI 9310 inner and AISI 9310 outer spline combinations. The Electrolize coating was most effective in extending the induction period from 25 hr for the "no-coating" test to 75 hr—a three-fold improvement. In each case the splines were allowed to operate for about 0.012 in. of total spline wear.

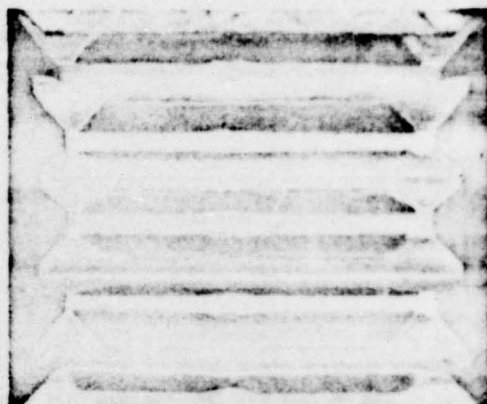
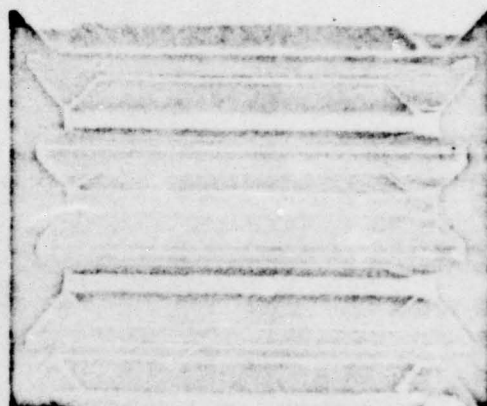
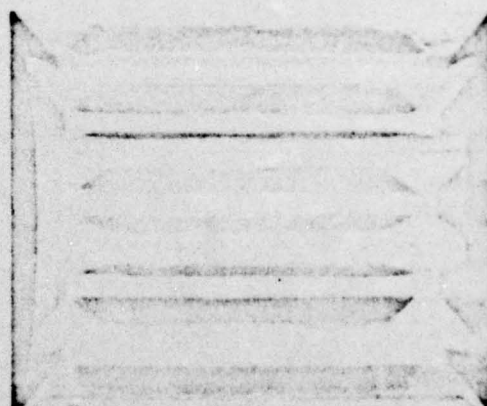
FIGURE 9. APPEARANCE OF SECTIONED STANDARD OUTER SPLINES
WITH METALLIC COATINGS

Figure 9 shows the appearance of the worn outer splines with metallic coatings. Three outer splines having Electrolize, electroless nickel II, and nickel boron were sectioned and photographed. Each photograph shows the wear steps which resulted on all of the twelve teeth. The wear steps on each spline tooth show up "dark" as a result of the forward and reverse loading tests.

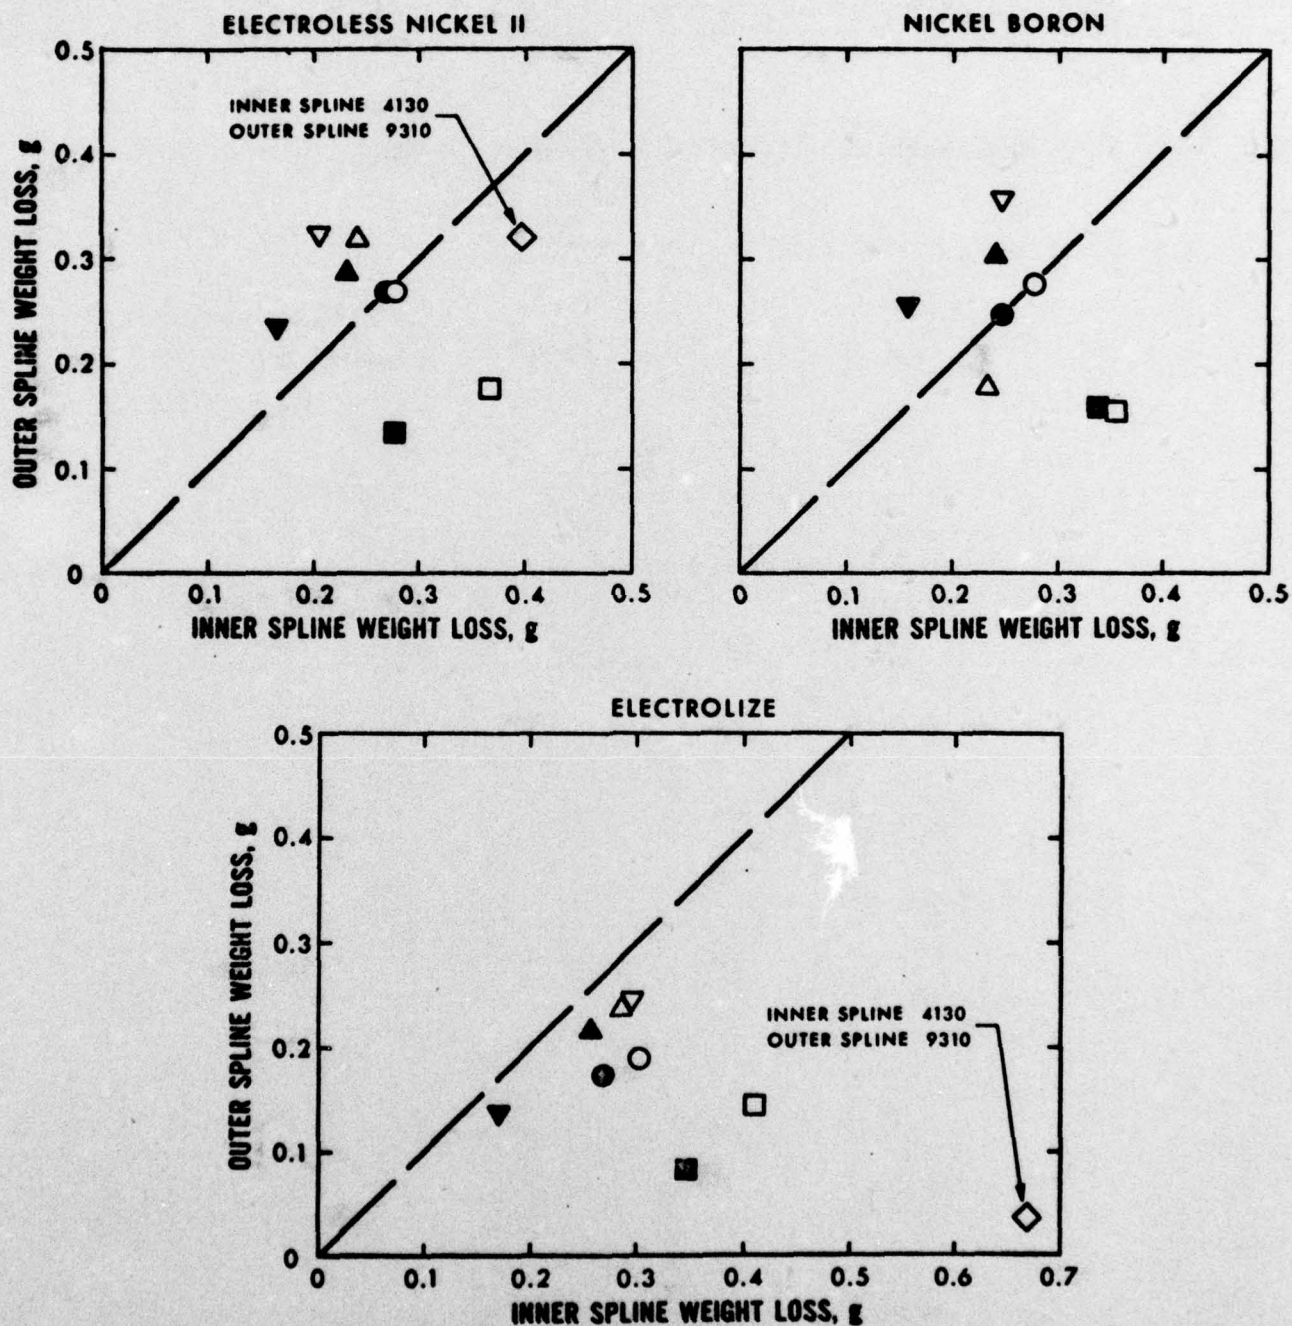
FIGURE 10. EFFECT OF WEIGHT LOSS ON STANDARD SPLINES FOR DIFFERENT MATERIAL COMBINATIONS WITH METALLIC COATINGS

inner and outer splines, indicating that the metallic coating on the outer spline was of little value in protecting the outer spline.

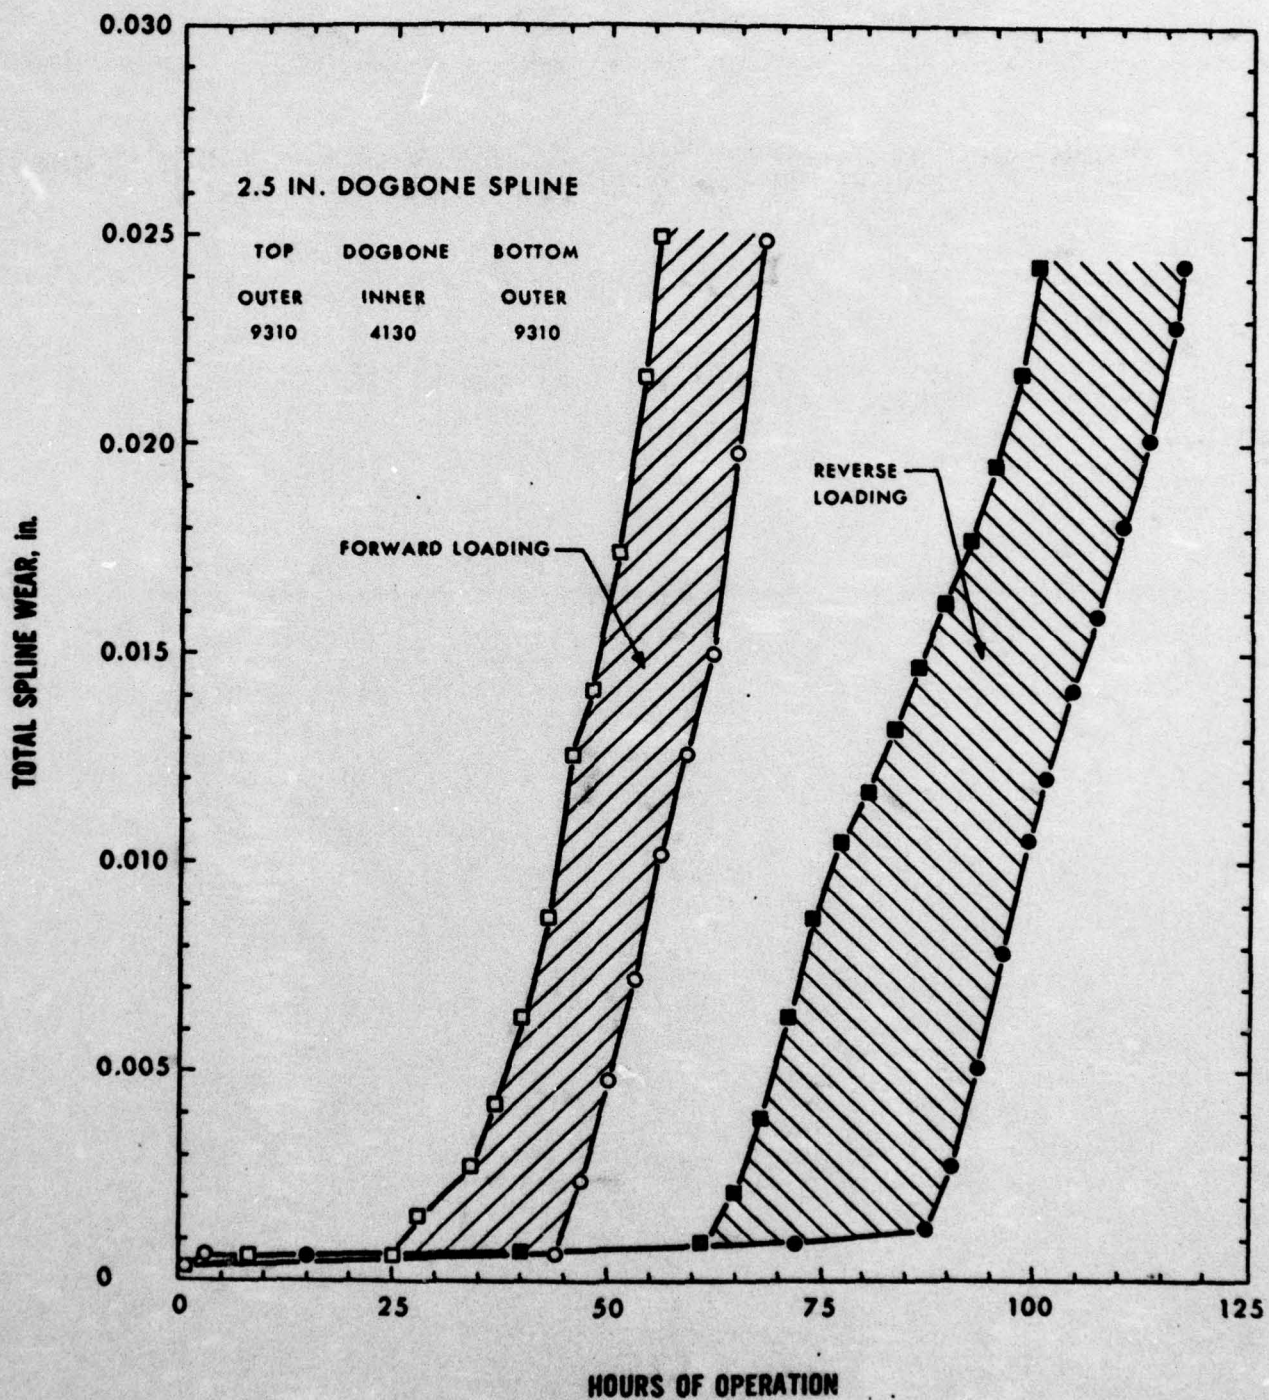
FIGURE 12. TYPICAL WEAR BEHAVIOR OF 2.5-IN. DOGBONE SPLINES FOR DIFFERENT MATERIAL COMBINATIONS

The typical wear behavior of a 2.5 in. dogbone operating with the MIL-G-81322B grease in dry air in the forward and reverse loading directions is shown in Figure 12. In these tests the upper and lower outer splines were made of AISI 9310 steel, while the dogbone (inner spline) was made of AISI 4130 steel. These tests were allowed to operate for about 0.025 in. of total spline wear (i.e., the total wear of all three members).

The wear behavior of these dogbone splines was quite similar to the standard splines, with the exception that after the typical run-in, some tests showed a low initial wear rate. This low wear rate continued up to the end of the induction period followed by a rapid increase in wear.

It was noted that the dogbone had a tendency to move up within the two outer splines when a misalignment was present. Therefore, the dogbone was axially restrained in the tests by the sheath thermocouple at the upper dogbone location. The vertical movement was due to the vertical force component imparted by the imposed spline misalignment.

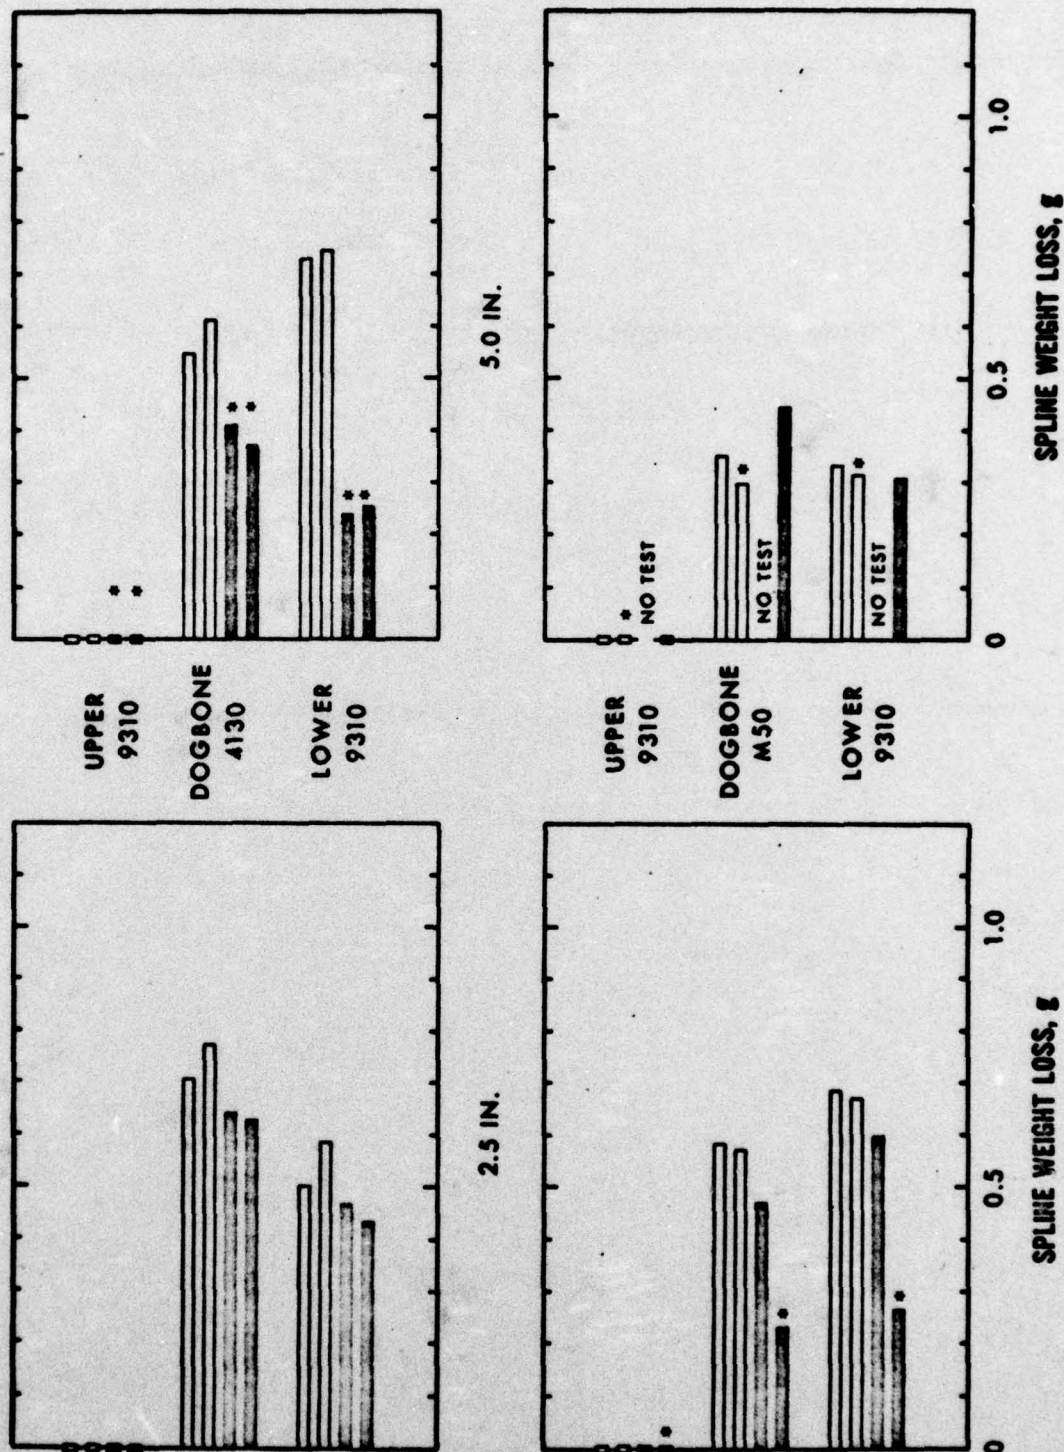
FIGURE 13. EFFECT OF WEIGHT LOSS ON DOGBONE SPLINES FOR DIFFERENT MATERIAL AND DESIGN COMBINATIONS

summarized in four bar charts with the charts on the left for the 2.5 in. dogbone tests and the ones on the right for the 5.0 in. dogbone tests. The upper charts contain the weight loss results for the AISI 4130 dogbones with the lower two charts for the AISI M50 dogbones. Most tests were operated for a total of 0.025 in. of total spline wear except for those noted by asterisks which were operated for 0.012 in. In all of the charts, the clear bars represent the forward loading tests, while the shaded bars represent the reverse loading tests.

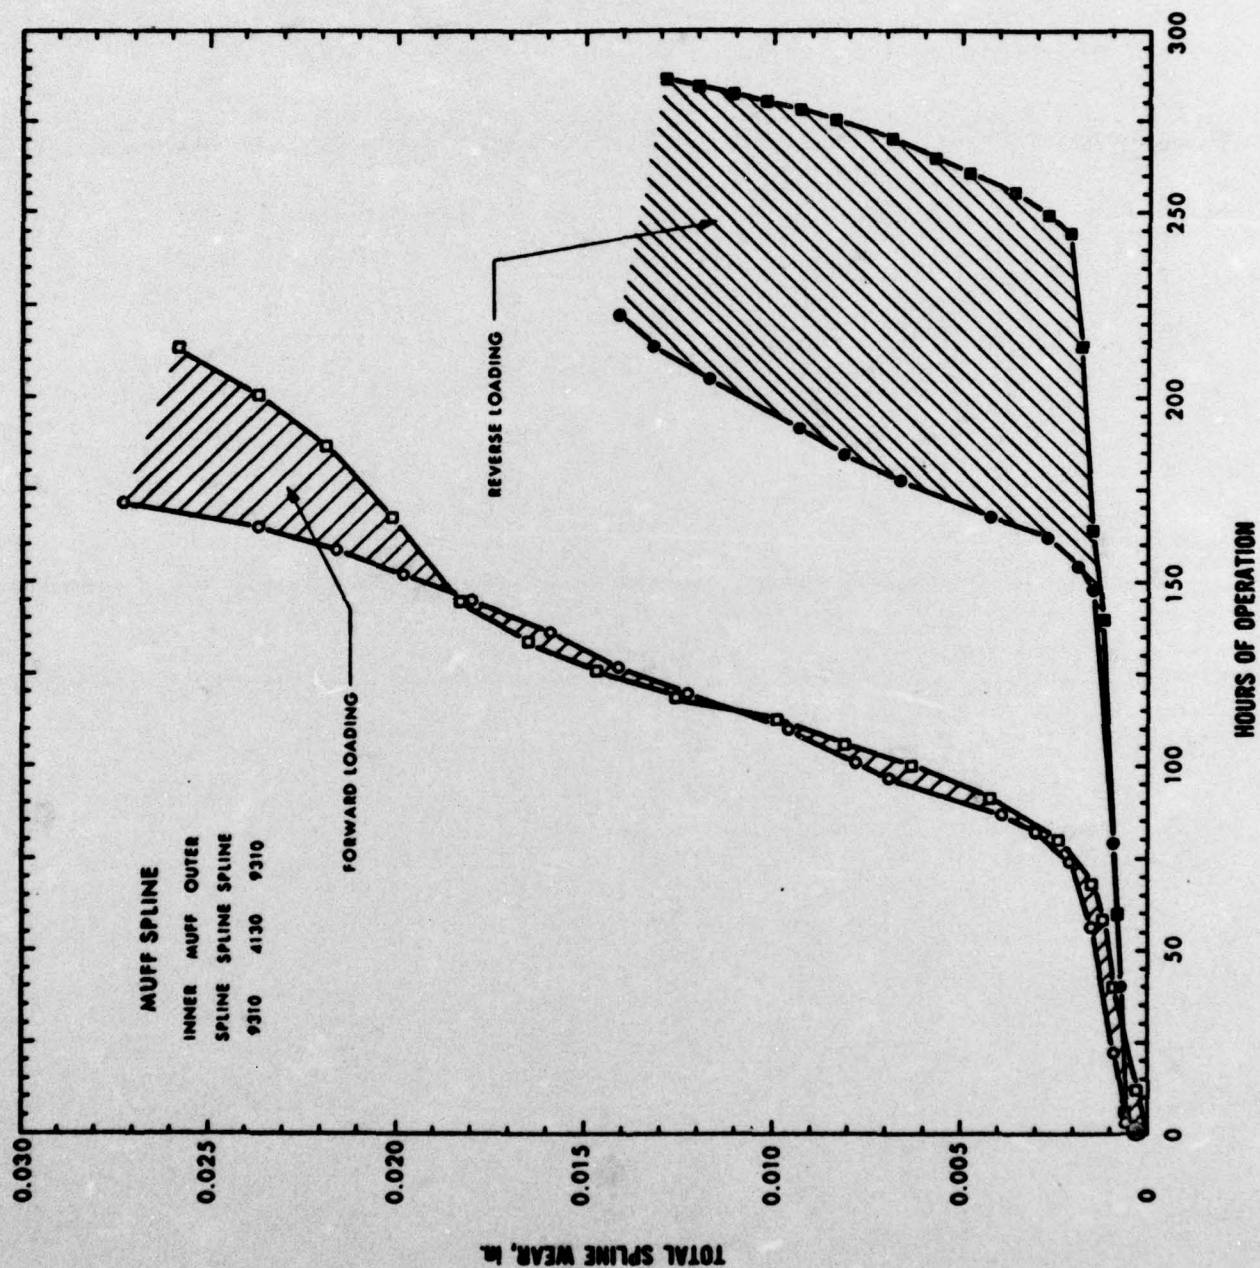
FIGURE 15. TYPICAL WEAR BEHAVIOR OF MUFF SPLINES FOR DIFFERENT MATERIAL COMBINATIONS

The typical wear behavior of muff splines operating with the MIL-G-81322B grease in dry air in the forward and reverse loading directions is shown in Figure 15. In these tests, the standard inner spline made of AISI 9310 steel was operated against a muff of AISI 4130 steel which also operated against an outer spline made of AISI 9310 steel.

The forward and reverse loading tests followed the same general trend as the standard and dogbone spline tests, in that the reverse loading tests operated for a longer period of time.

In all of the muff tests, the splines began to wear immediately at a low rate of wear and continued to the end of the induction period, after which the wear rate increased rapidly. The transition between the low and high wear rates (end of the induction period) was gradual.

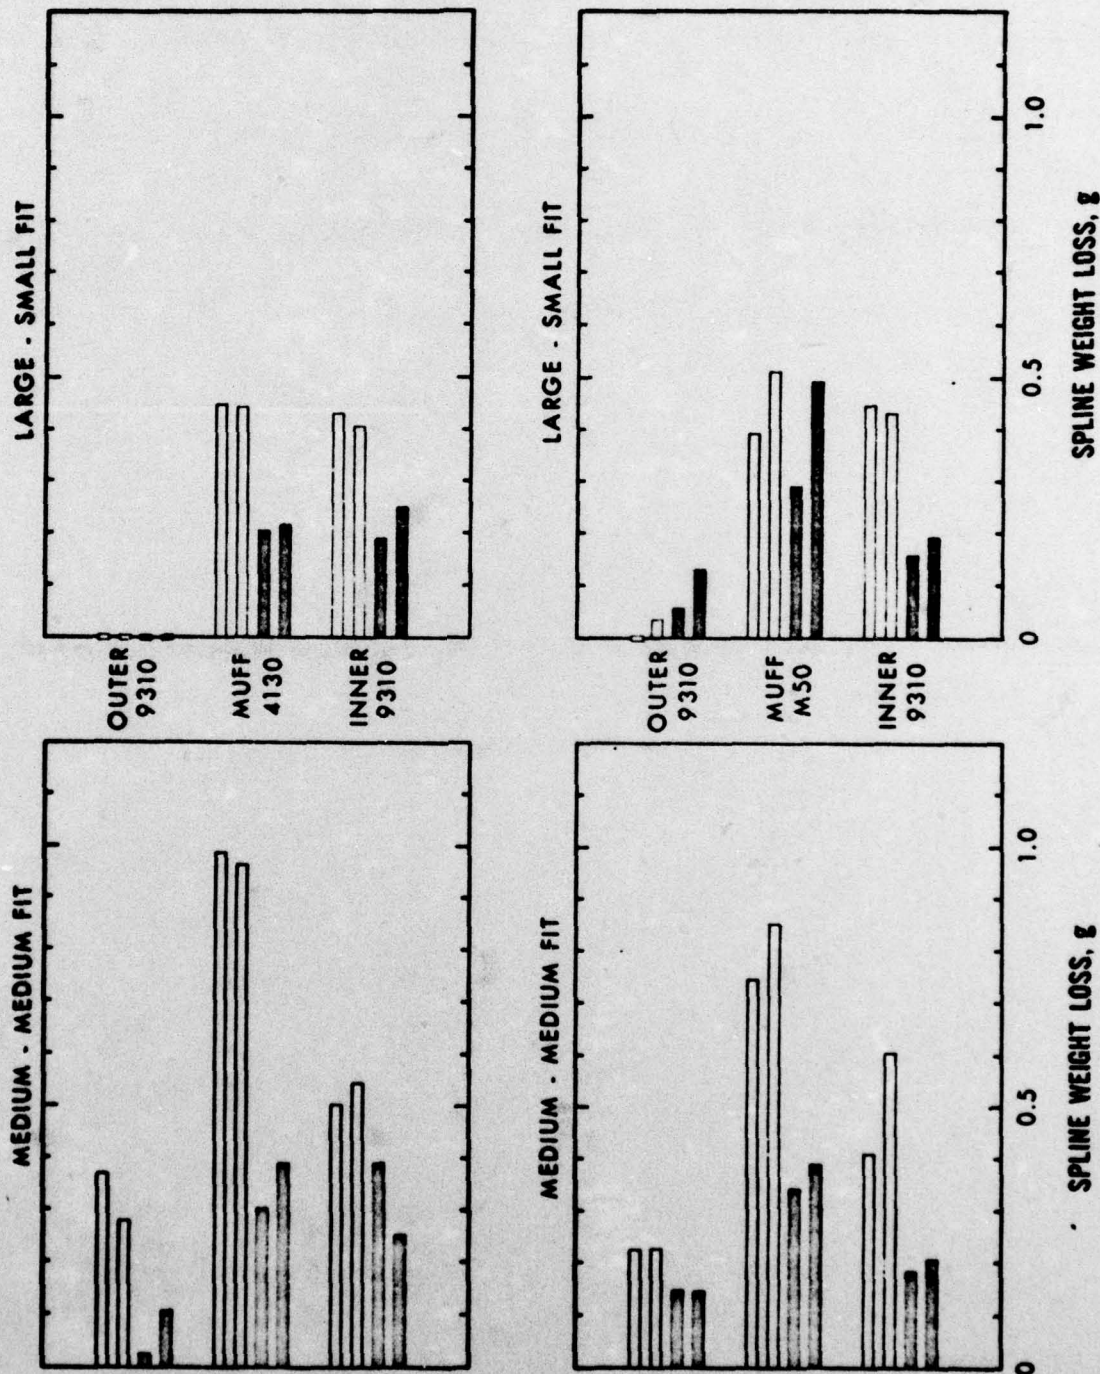
FIGURE 16. EFFECT OF WEIGHT LOSS ON MUFF SPLINES FOR DIFFERENT MATERIAL AND DESIGN COMBINATIONS

When AISI M50 steel was used as the muff material, the same general trend resulted for both the medium-medium and large-small fits used.
